**KWARA STATE POLYTECHNIC ILORIN, KWARA STATE.
INSTITUTE OF TECHNOLOGY
DEPARTMENT OF CIVIL ENGINEERING**

**ASSESSMENT OF ROAD PAVEMENT DETERIORATION AND
MAINTENANCE STRATEGY (KILANKO ROAD OFFA
GARAGE**

**BY
AKOLADE EBENEZER OLAOLUWA
HND/23/CEC/FT/0271**

**IN PARTIAL FULFILMENT OF THE REQUIREMENT FOR THE
AWARD OF HIGHER NATIONAL DIPLOMA (HND) IN CIVIL
ENGINEERING**

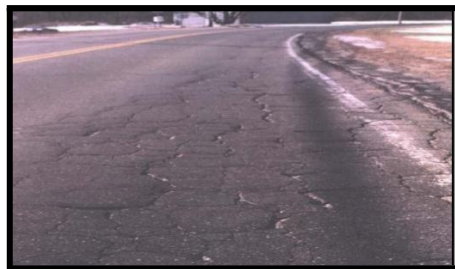
Fatigue cracking is commonly called alligator cracking. This is a series of interconnected cracks creating small, irregular shaped pieces of pavement. It is caused by failure of the surface layer or base due to repeated traffic loading (fatigue). Eventually the cracks lead to disintegration of the surface, as shown in Figure. The final result is potholes. Alligator cracking is usually associated with base or drainage problems. Small areas may be fixed with a patch or area repair. Larger areas require reclamation or reconstruction. Drainage must be carefully examined in all cases.

Fig:2. High severity alligator cracking

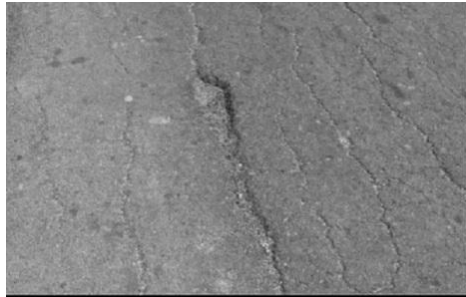
Longitudinal cracks are long cracks that run parallel to the center line of the roadway.

These may be caused by frost heaving or joint failures, or they may be load induced. Understanding the cause is critical to selecting the proper repair. Multiple parallel cracks may eventually form from the initial crack. This phenomenon, known as deterioration, is usually a sign that crack repairs are not the proper solution

Fig:3. Longitudinal Cracking

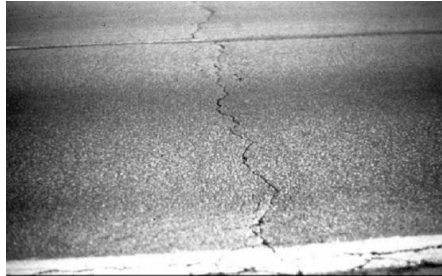
Transverse cracks form at approximately right angles to the centerline of the roadway. They are regularly spaced and have some of the same causes as longitudinal cracks. Transverse cracks will initially be widely spaced (over 20 feet apart). They usually begin as hairline or very narrow cracks and widen with age. If not properly sealed and maintained, secondary or multiple cracks develop, parallel to the initial crack. The reasons for transverse cracking, and the repairs, are similar to those for longitudinal cracking. In addition, thermal issues can lead to low-temperature cracking if the asphalt cement is too hard. Figure shows a low-severity

Fig:5. Low severity transverse crack

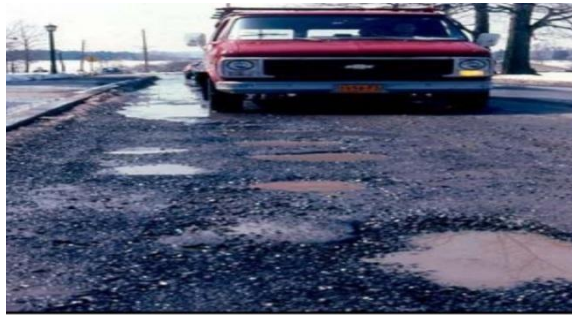
Potholes are bowl-shaped holes similar to depressions. They are a progressive failure. First, small fragments of the top layer are dislodged. Over time, the distress will progress downward into the lower layers of the pavement. Potholes are often located in areas of poor drainage, as seen in Figure. Potholes are formed when the pavement disintegrates under traffic loading, due to inadequate strength in one or more layers of the pavement, usually accompanied by the presence of water. Most potholes would not occur if the root cause was repaired before development of the pothole. Repair by excavating and

Fig: 6. Potholes cause by poor drainage

rebuilding. Area repairs or reconstruction may be required for extensive potholes.

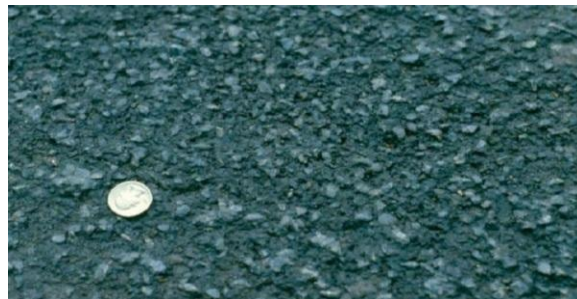
loose and leaves small, rough patches in the surface of the pavement. As the disintegration continues, larger aggregate breaks loose, leaving rougher surfaces.

Fig: 7. High severity ravelling of asphalt surface

Ravelling can be accelerated by traffic and freezing weather. Some ravelling in chip seals is due to improper construction technique. This can also lead to bleeding. Repair the problem with a wearing course or an overlay.
