**KWARA STATE POLYTECHNIC, ILORIN
INSTITUTE OF TECHNOLOGY
DEPARTMENT OF CIVIL ENGINEERING**

**EVALUATION OF TRAFFIC MANAGEMENT
SYSTEM ALONG ILORIN- BODE SAADU ROAD.**

**BEING A RESEARCH WORK SUBMITTED TO THE DEPARTMENT
OF CIVIL ENGINEERING, INSTITUTE OF TECHNOLOGY, KWARA
STATE POLYTECHNIC, ILORIN, KWARA STATE.**

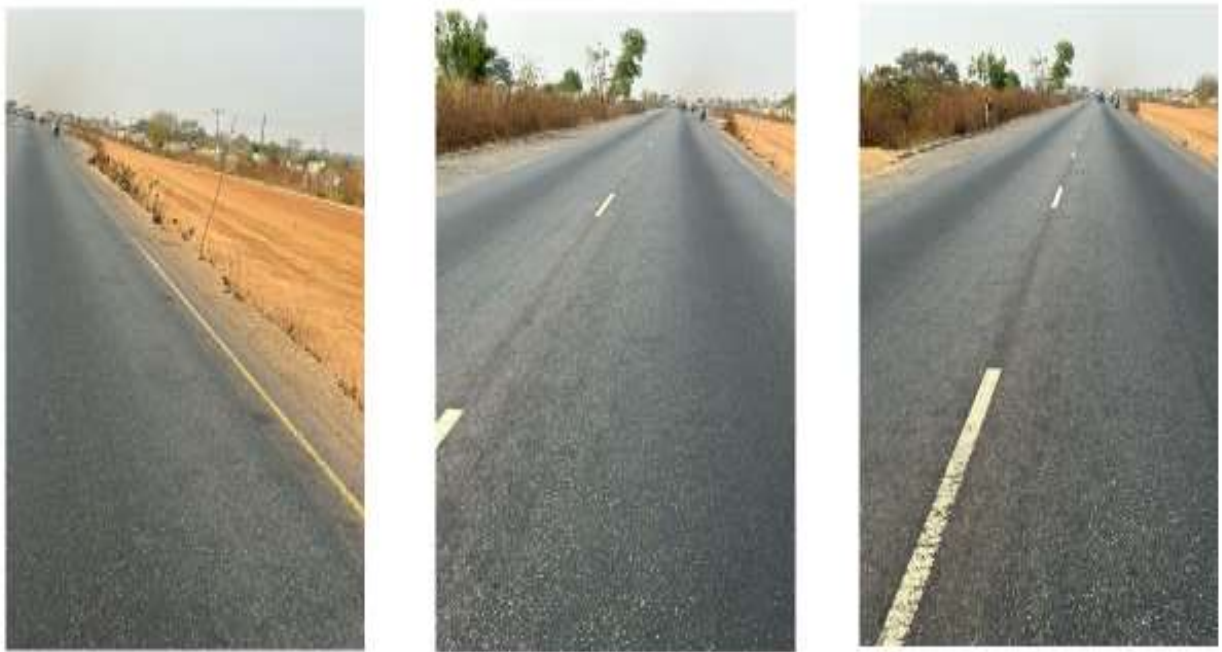
Fig 1.2.3 Images showing road markings along the Ilorin-Bode saadu highway

- **Condition and sufficiency:** The study observed that there was no road signage along the most part of the road although this is due to the on-going rehabilitation along the entire route and elsewhere along the road a significant number of signs are in poor condition- faded, damaged, or insufficient in number. This degradation diminishes their effectiveness, leading to driver confusion and reduced compliance with road regulations.
- **Road Marking:** The painted road markings are visibly deteriorating, with reports of peeling and rip-offs. This deterioration not only compromises lane discipline but also contributes to navigation errors, especially during adverse weather conditions and in areas undergoing road rehabilitation.

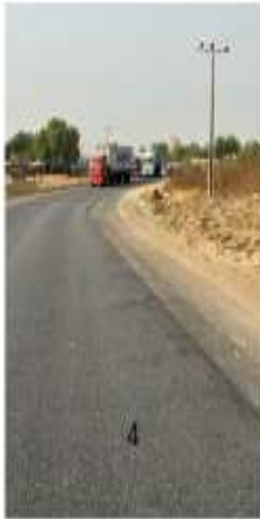
- Fig4.** insufficient curvature & Absence of road signage
Fig5. Deteriorating condition of The speed bump
Fig6. Blockage due to construction
Fig7. On going construction along The route
Fig8. Introduction of bridge along The route
Fig9. Diversion due to on going Rehabilitation
Fig10. Bottleneck/congestion along The route.
